Snowdens Mill/Falling Creek Stream Restoration

Public Meeting
January 23, 2018

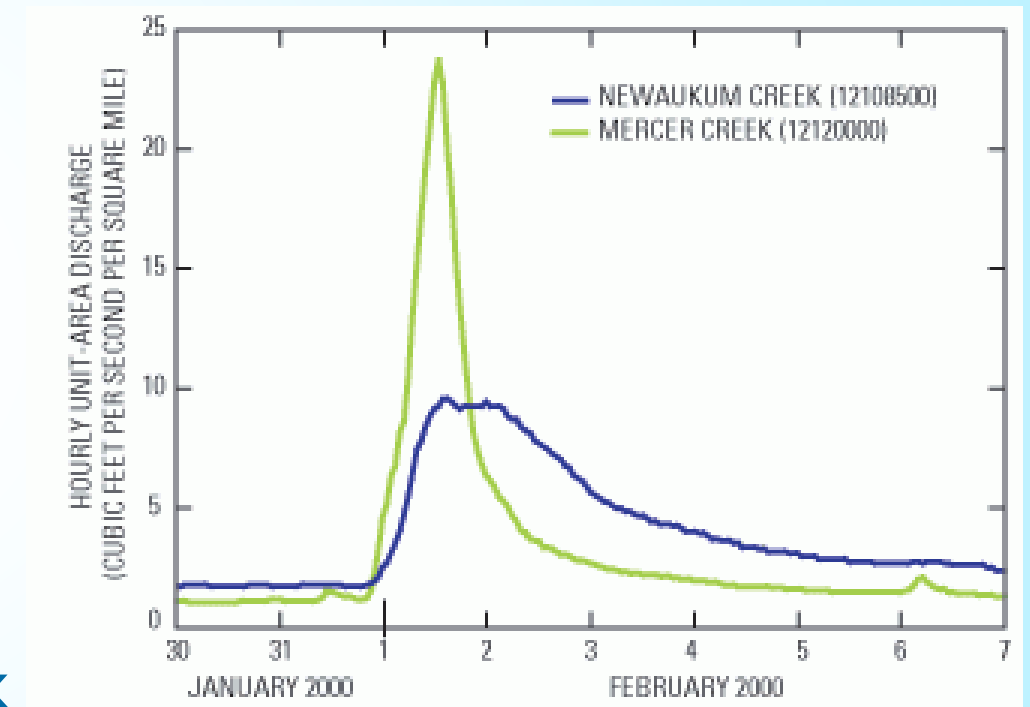
Urban vs. Forested Watersheds

► Urban Mercer Creek

- Streamflow increases more quickly
- Higher Peak Flow
- Lower Baseflow
- Flash Floods
- Increased Erosion

► Forested Newaukum Creek

- Lower peak flow – slower to rise
- Higher base flow during periods of no rain → Supports fish

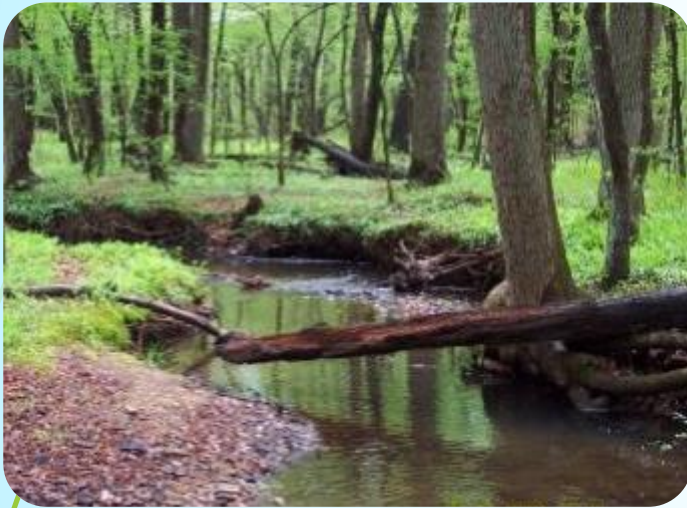
Stream in a watershed with **8%** impervious cover.

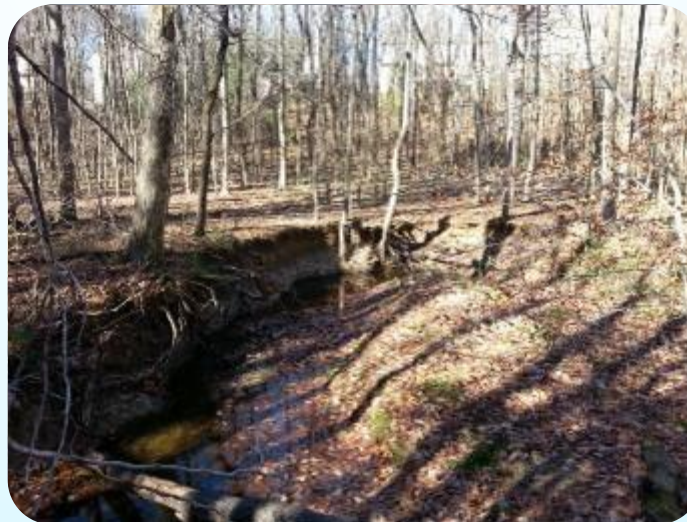
Stream in a watershed with **20%** impervious cover.

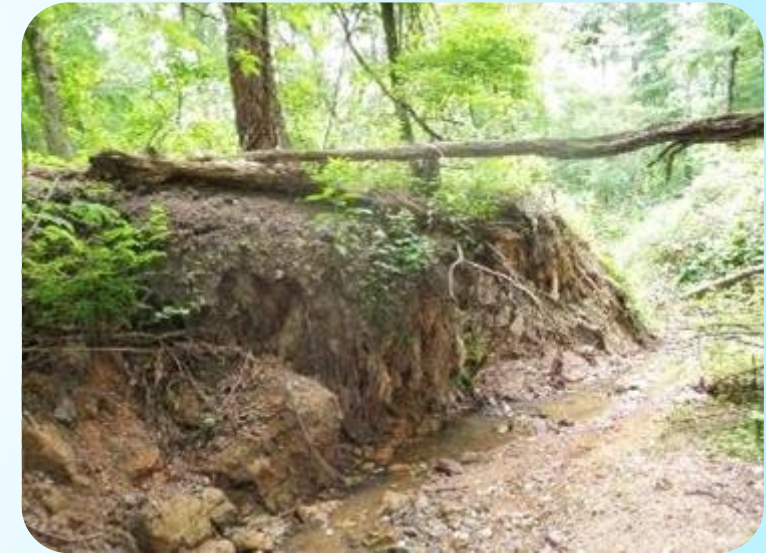
Stream in a watershed with **30%** impervious cover.

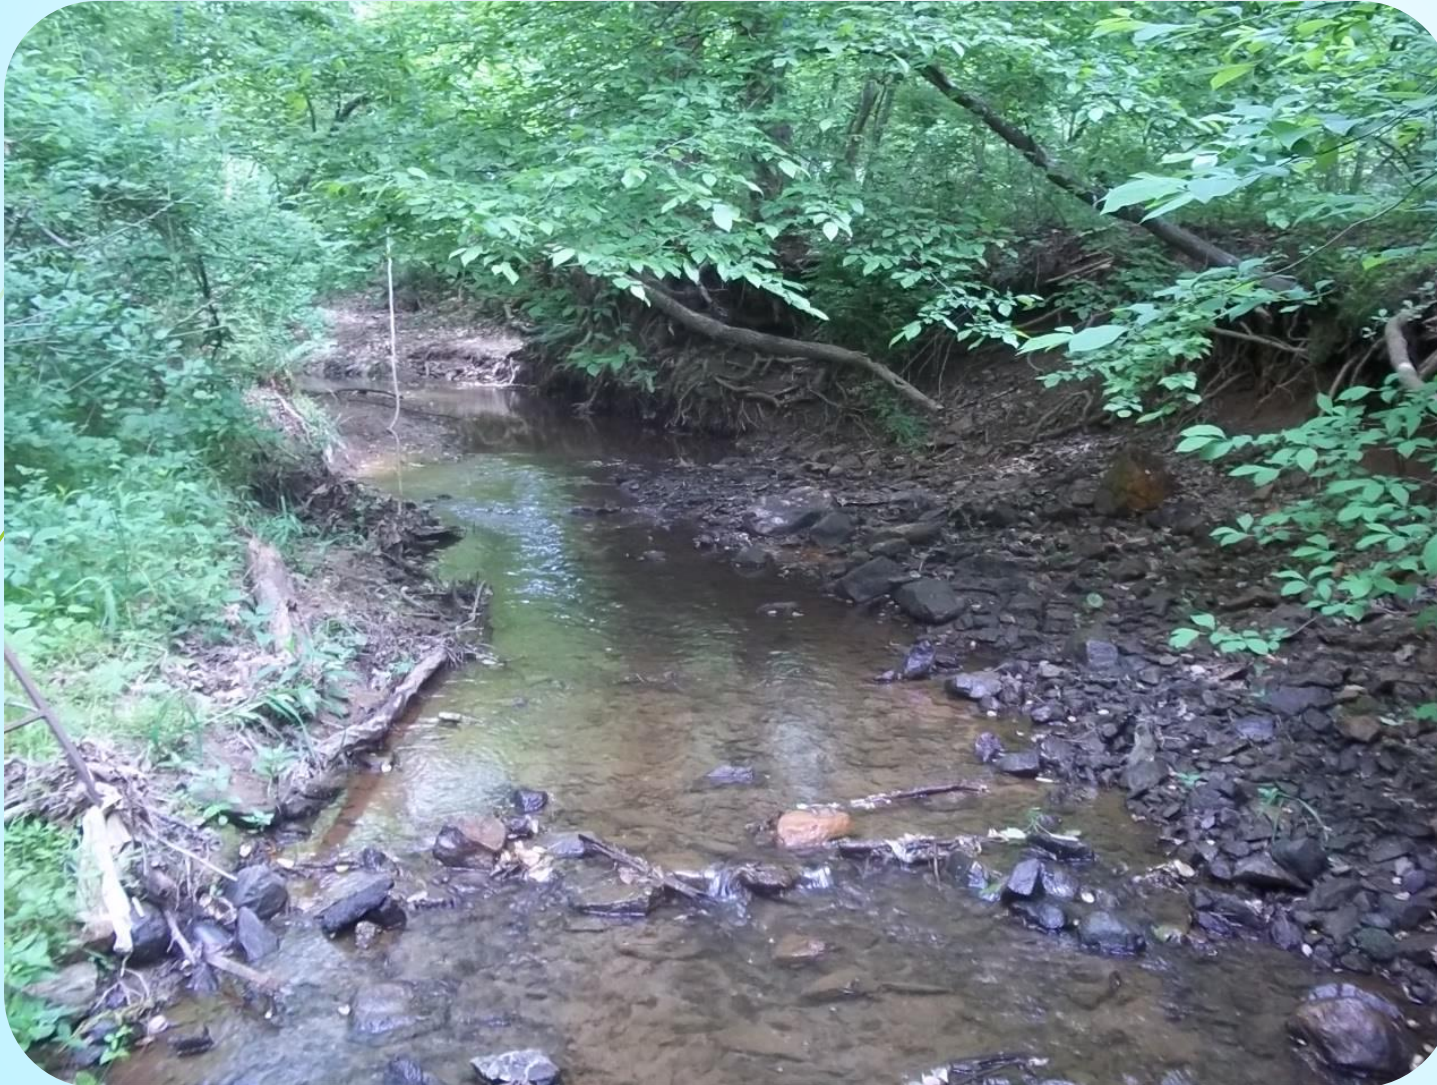
*Typical conditions of
Snowdens Mill channel in
lower reach downstream
of Serpentine Road*

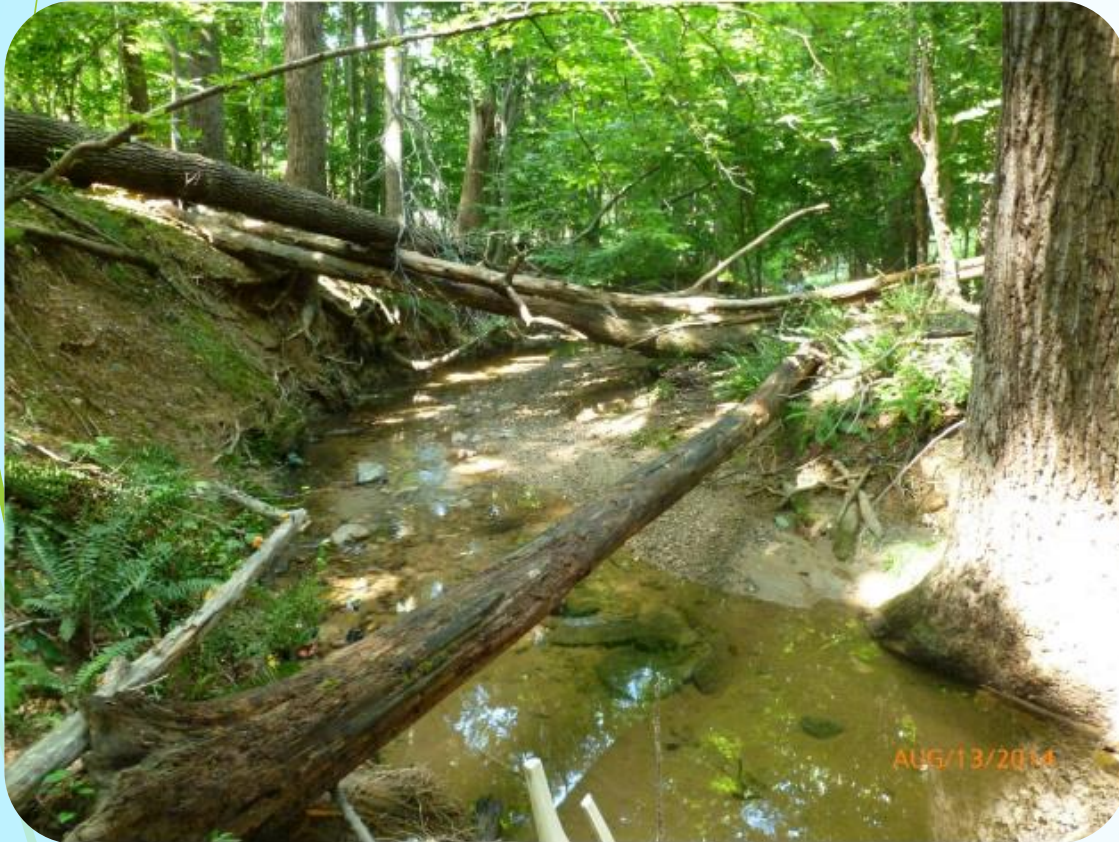
Snowdens Mill typical conditions in the Middle Reach (between Serpentine Way and Falling Creek Court) showing routine erosion of channel banks and under floodplain root zone

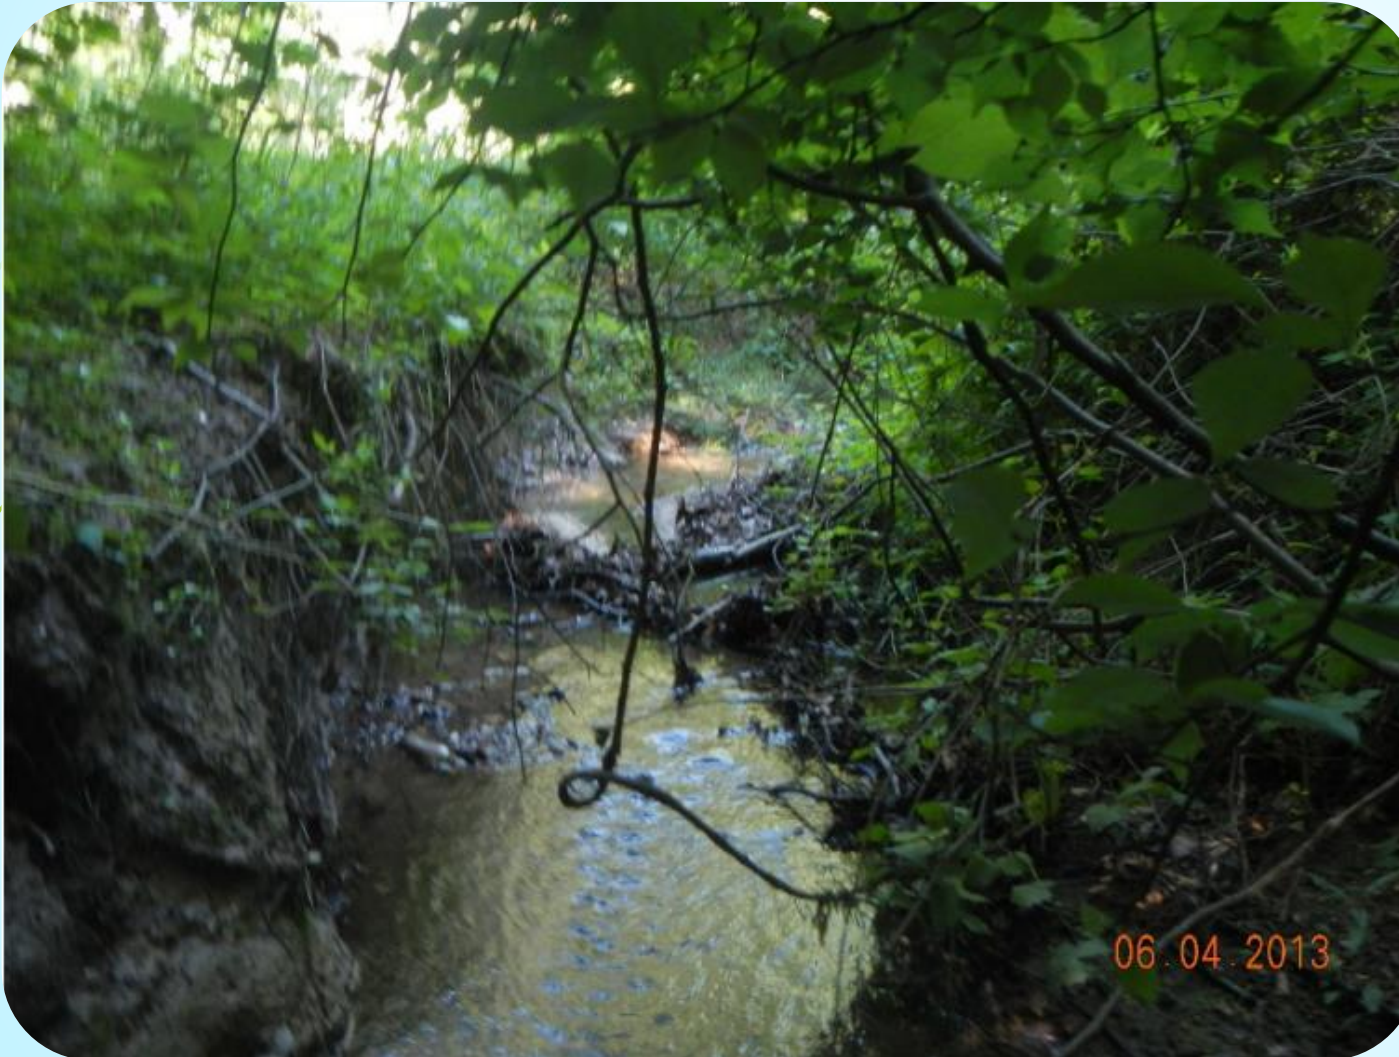
*Eroded stream banks and
invasive plants in Snowdens
Mill Upper Reach (upstream of
Falling Creek Road*

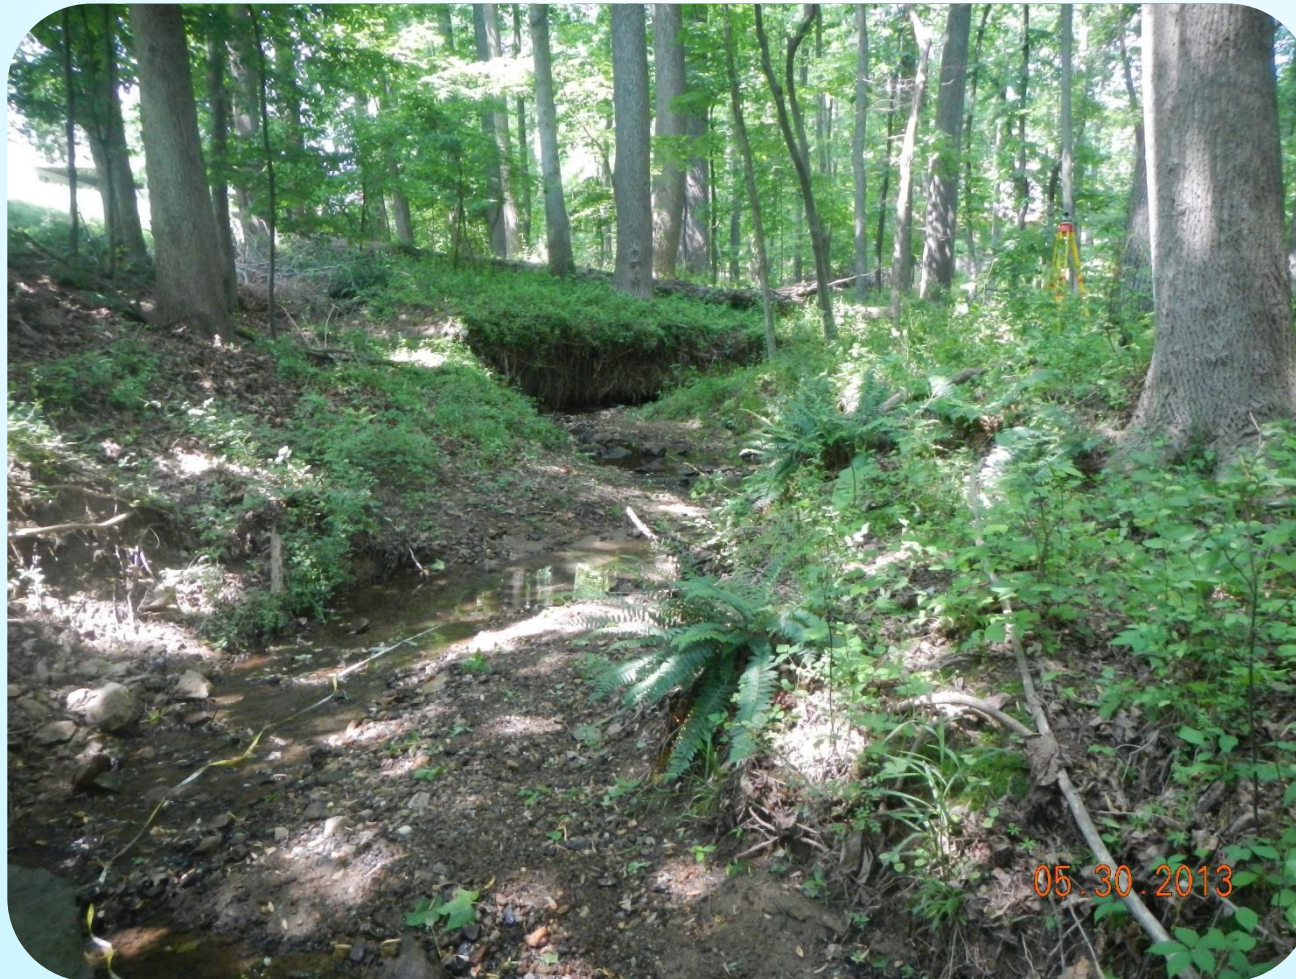
Typical conditions of Falling Creek channel in lower reach downstream of Falling Creek Ct.

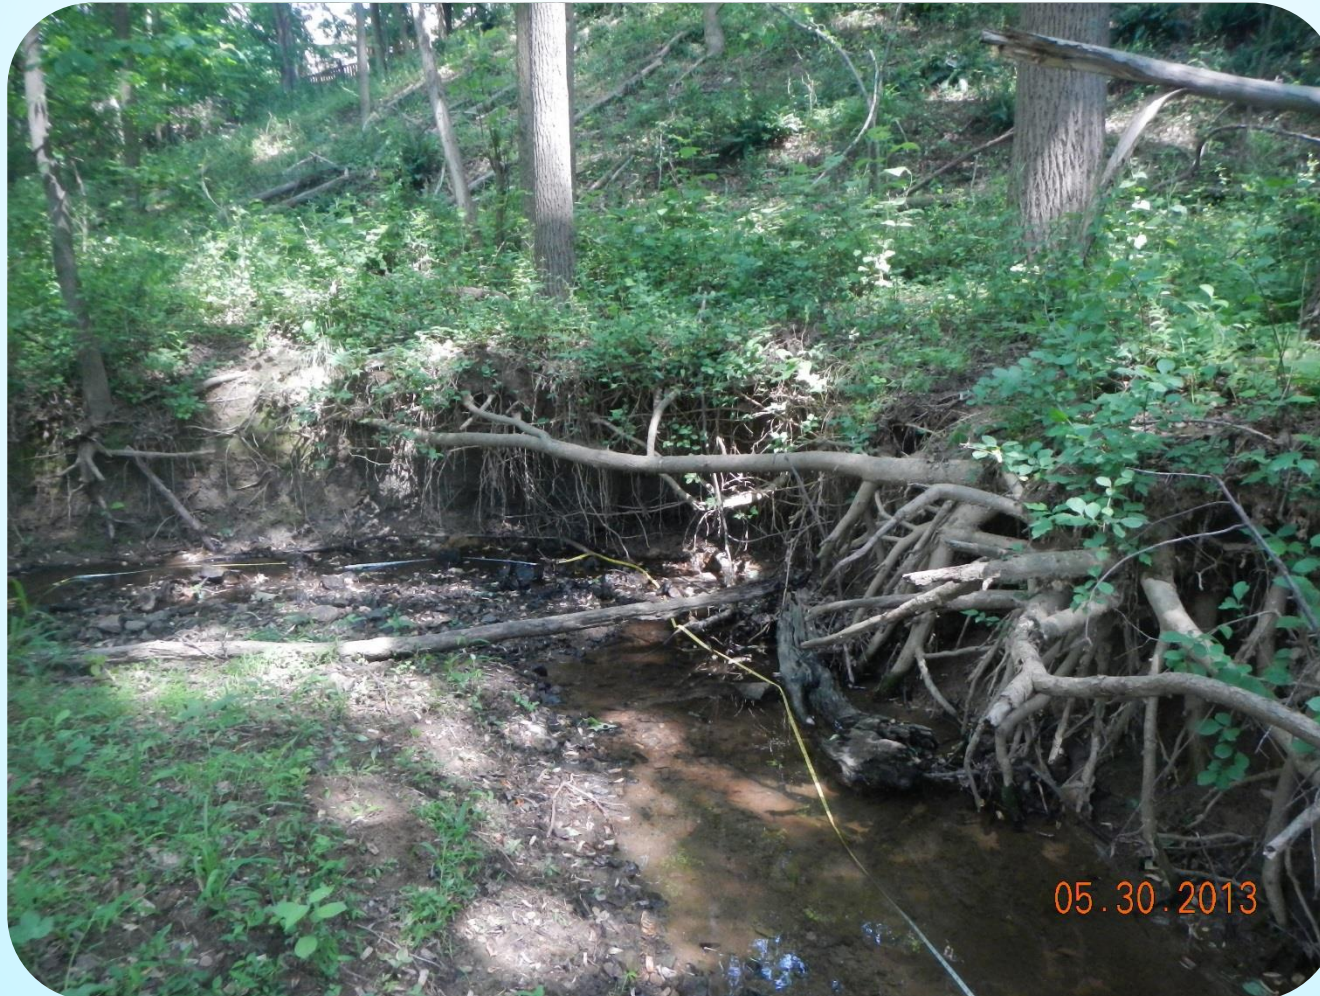
Routine erosion of channel banks and under floodplain root zone. Trees will eventually fall into the stream.

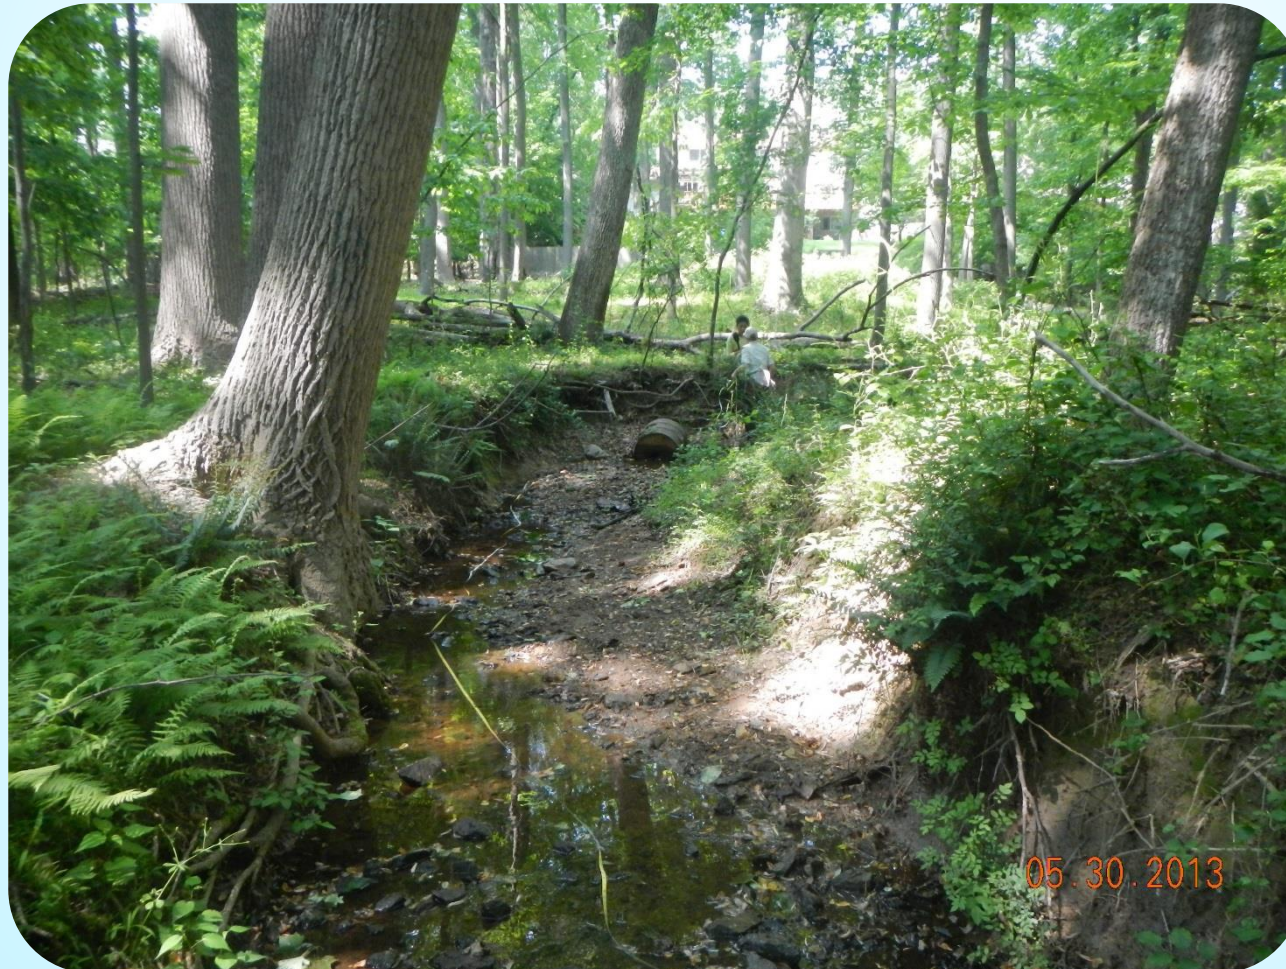
*Eroded stream banks, debris,
and invasive plants in Lower
Falling Creek Reach*

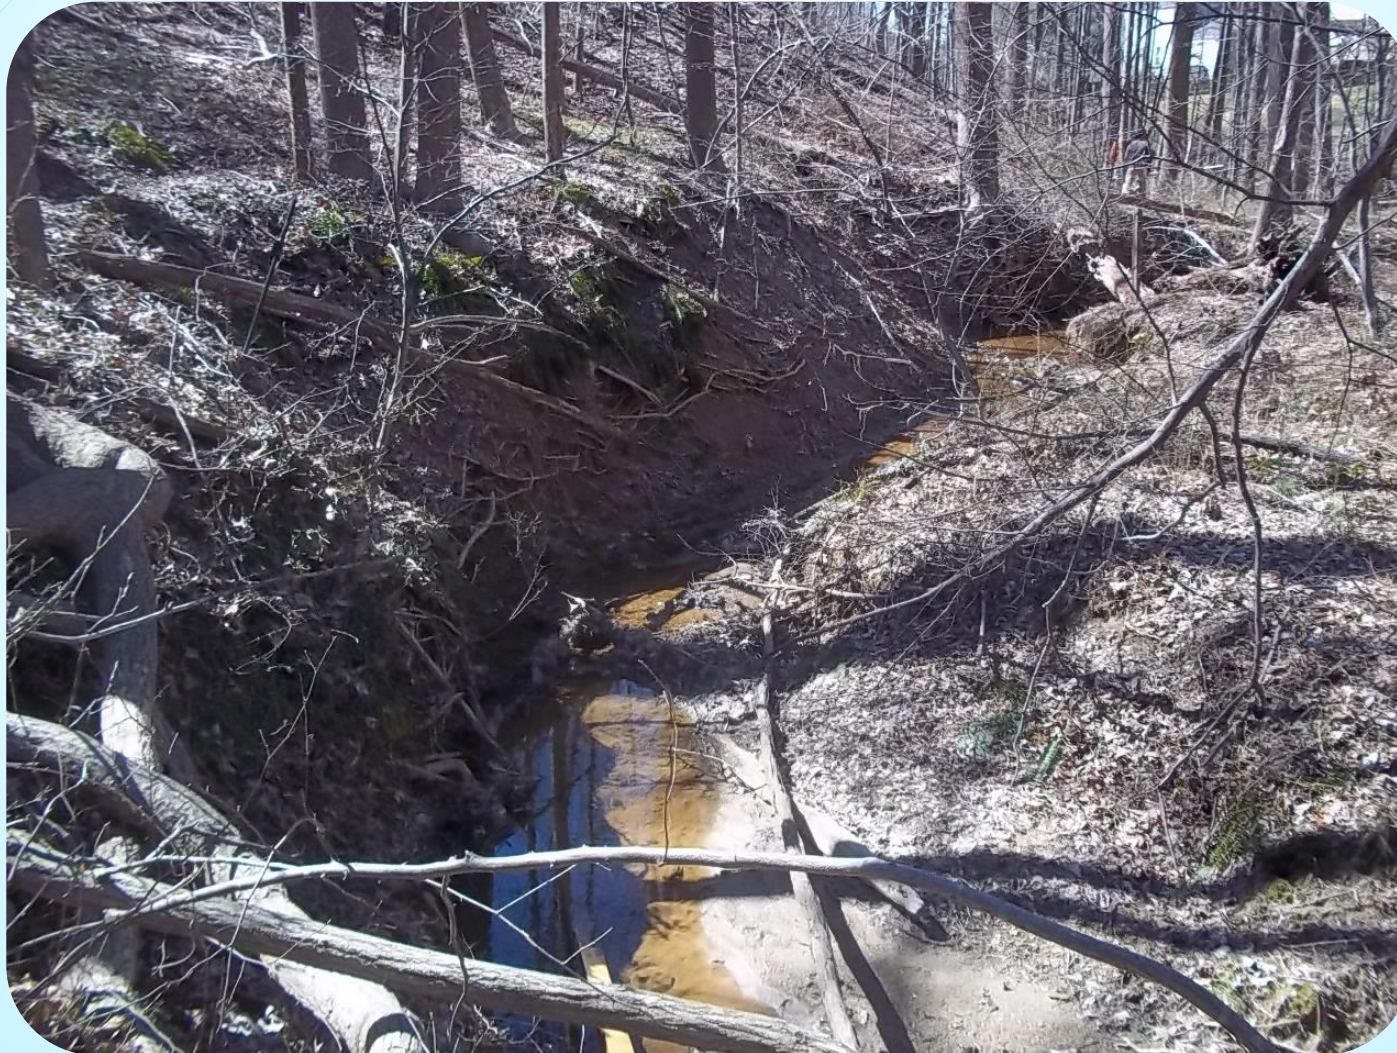
Channel migration to valley hill slope causing tree fall in lower section of Falling Creek (downstream of Falling Creek Court).
